RE: NSPS Subpart OOOOa Annual Report

Annual Report - OOOOa

Leak Detection and Repair (LDAR) Recordkeeping Form

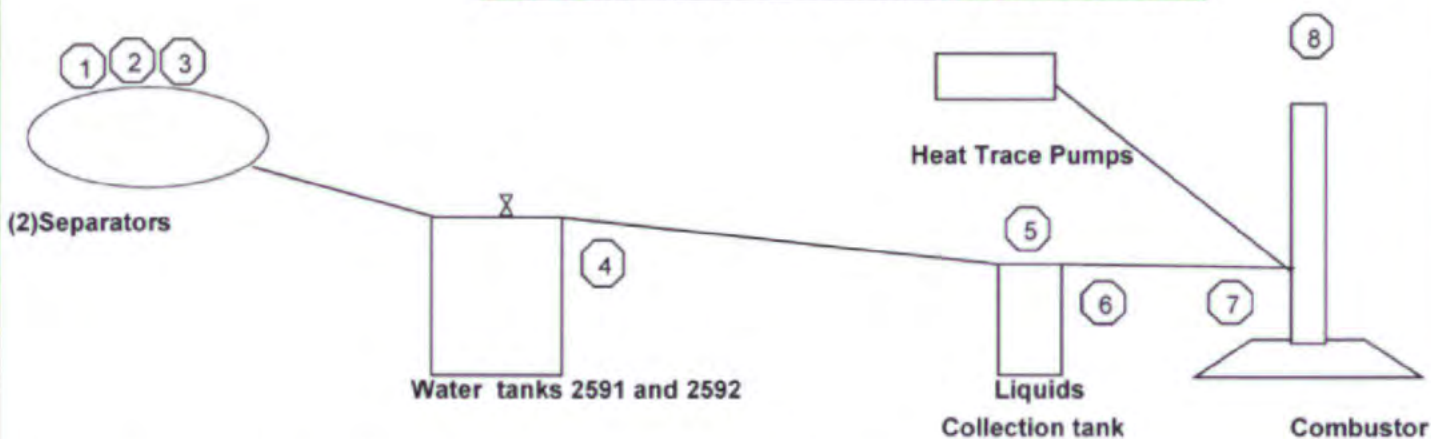
Simplified Process Flow for Condensate Tank to Combustor

ID	Description	LEL Reading or Visual Inspection	Comments
Separator			SEE COMMENTS BELOW
1	Rupture Disk - LEL READING	OK	
2	Relief Valve - LEL READING	OK	
3	Inspection of piping (inlet, outlet, dump lines)	OK	
Tanks #2591 and 2592			
4	Inspection of piping to collection tank	OK	
5	Inspection of collection tank, plugs, valves	OK	
Combustor			
6	Inspection of piping collection tank to combustor	OK	
7	Pilot and burner on combustor - ANALOG READING	OK	
8	Inspection of stack emissions - CLEAR, SMOKING etc.	OK
